Samples of Photos Taken by ODOT OIS Investigator John Shore on April 22, 2014

Exhibit 2

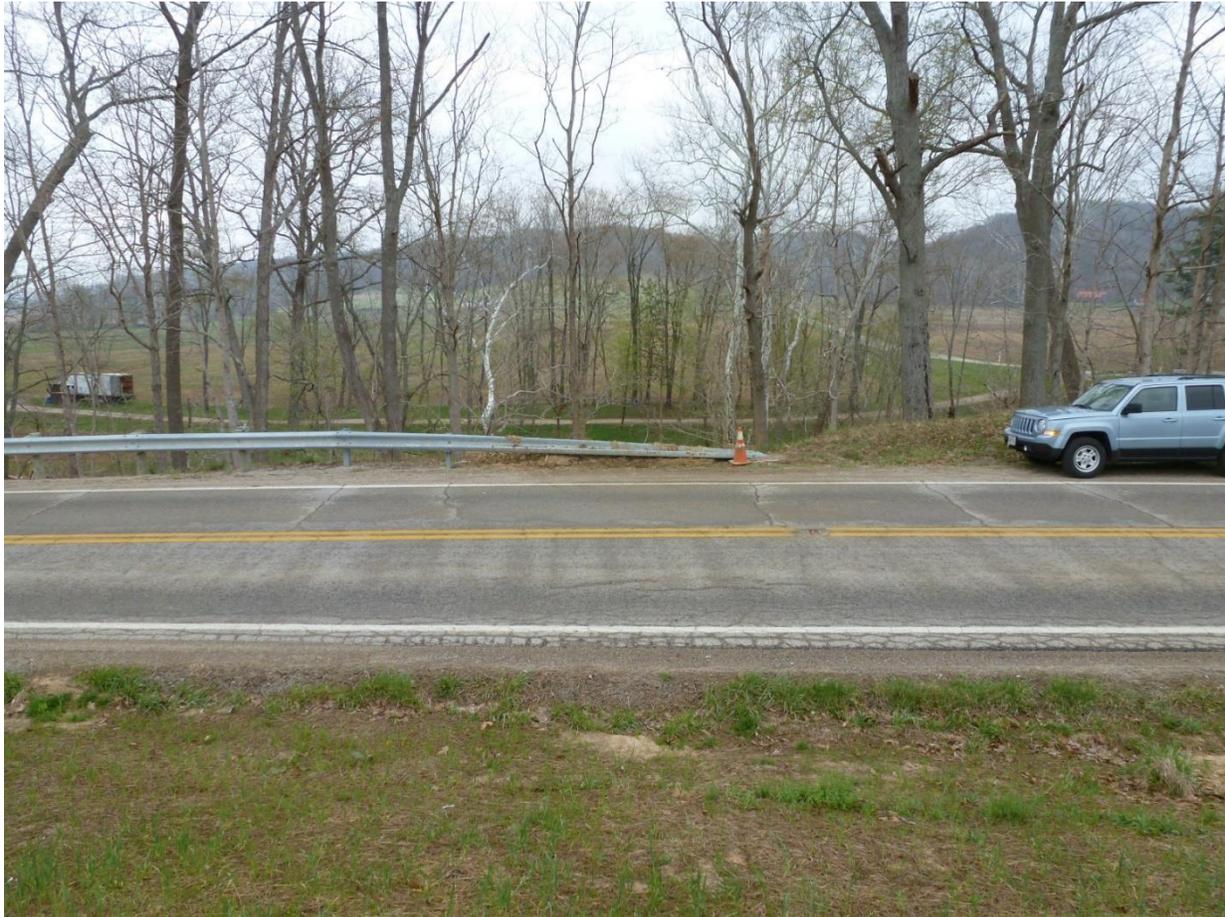
View from other side of roadway. Cone is where trucks backed up to guardrail and dumped dirt over the rail. Drive and truck in background are on other side of the creek.

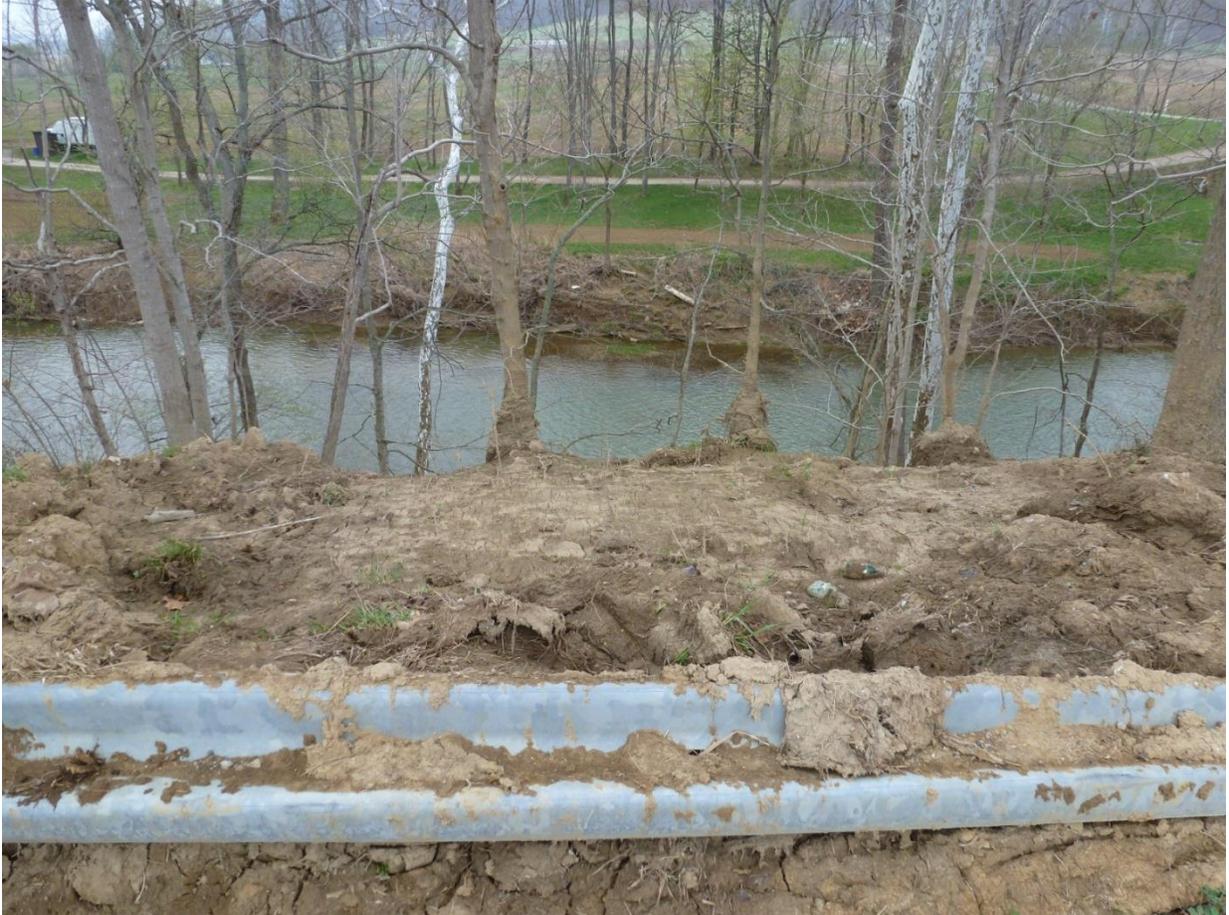
Standing at guardrail, cone in other pictures is to immediate right. There is approximately 5-10 feet of gradually sloping terrain, and then at tree on far right slope goes to steep embankment, down to river. There is no accumulation (depth) of material at this point, other than what is under the guardrail. Everything else slid down the embankment.

As shown, creek is clearly visible.

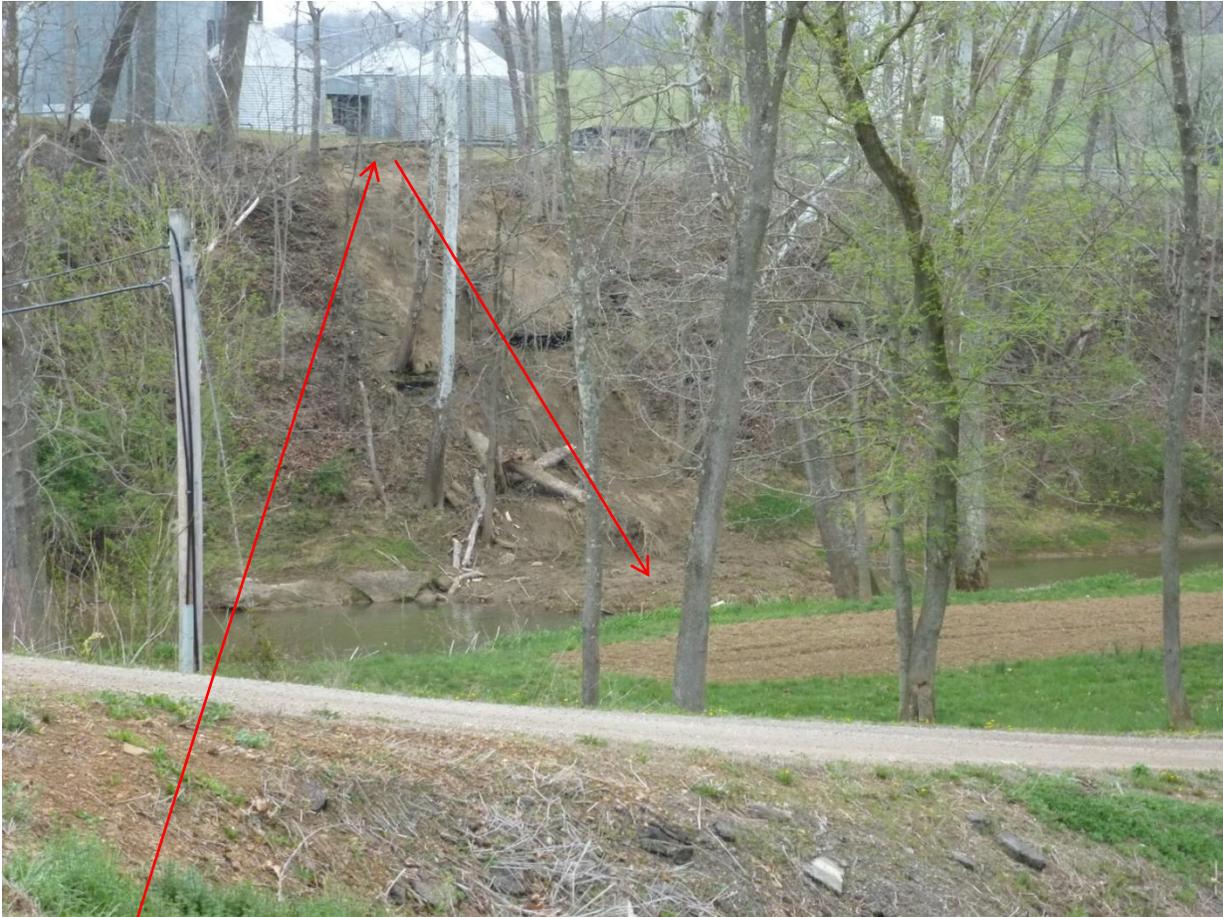
This view is from the drive on the opposite side of the creek. The guardrail where the trucks dumped from is here. Estimate that the embankment is 50-60 feet in height.

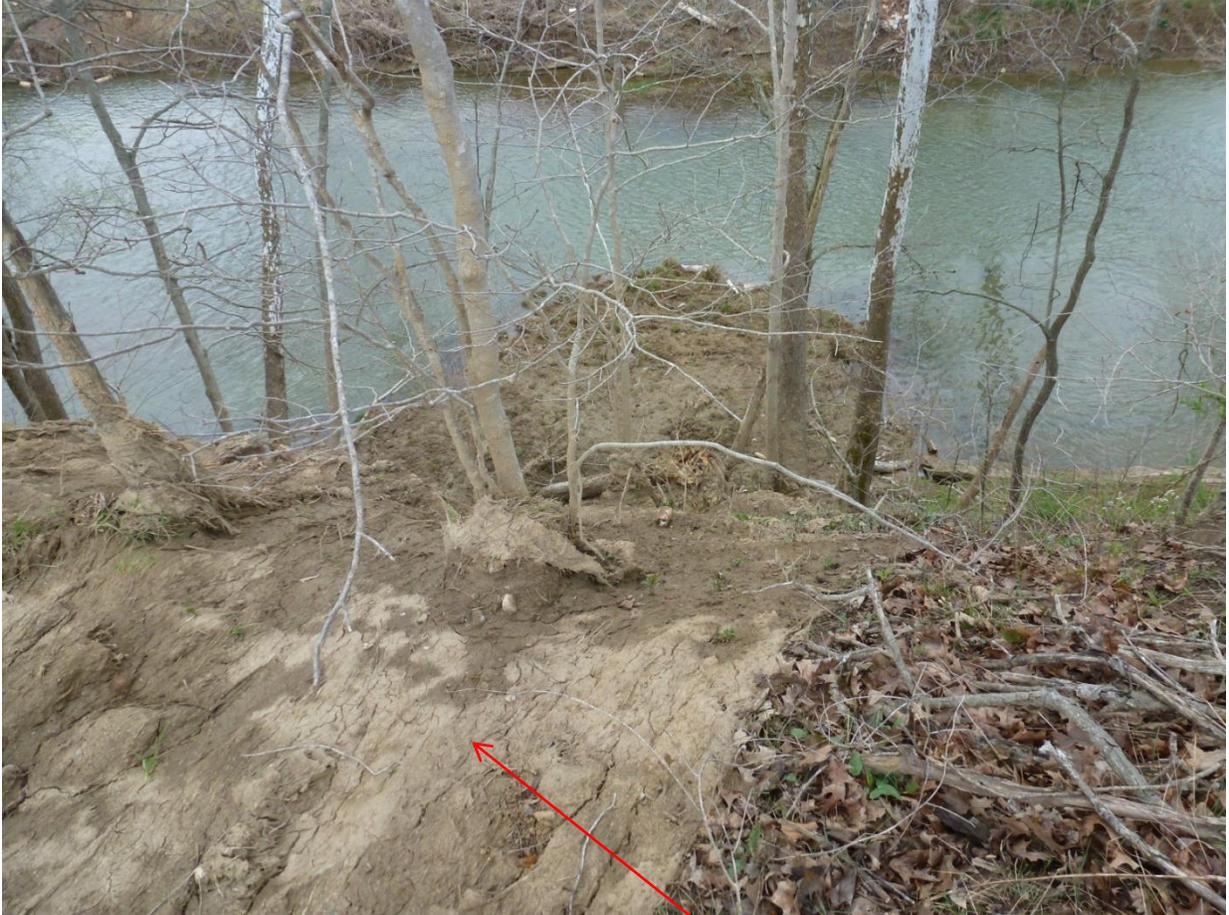
Standing on the 5-10 feet of gradual slope, just on the other side of the guardrail. Obvious how the material slid down the embankment and into the creek. The dirt here is no deeper than sitting on top of the leaves.

Standing at the guardrail, or perhaps in the cab of a dump truck, the creek would be visible.

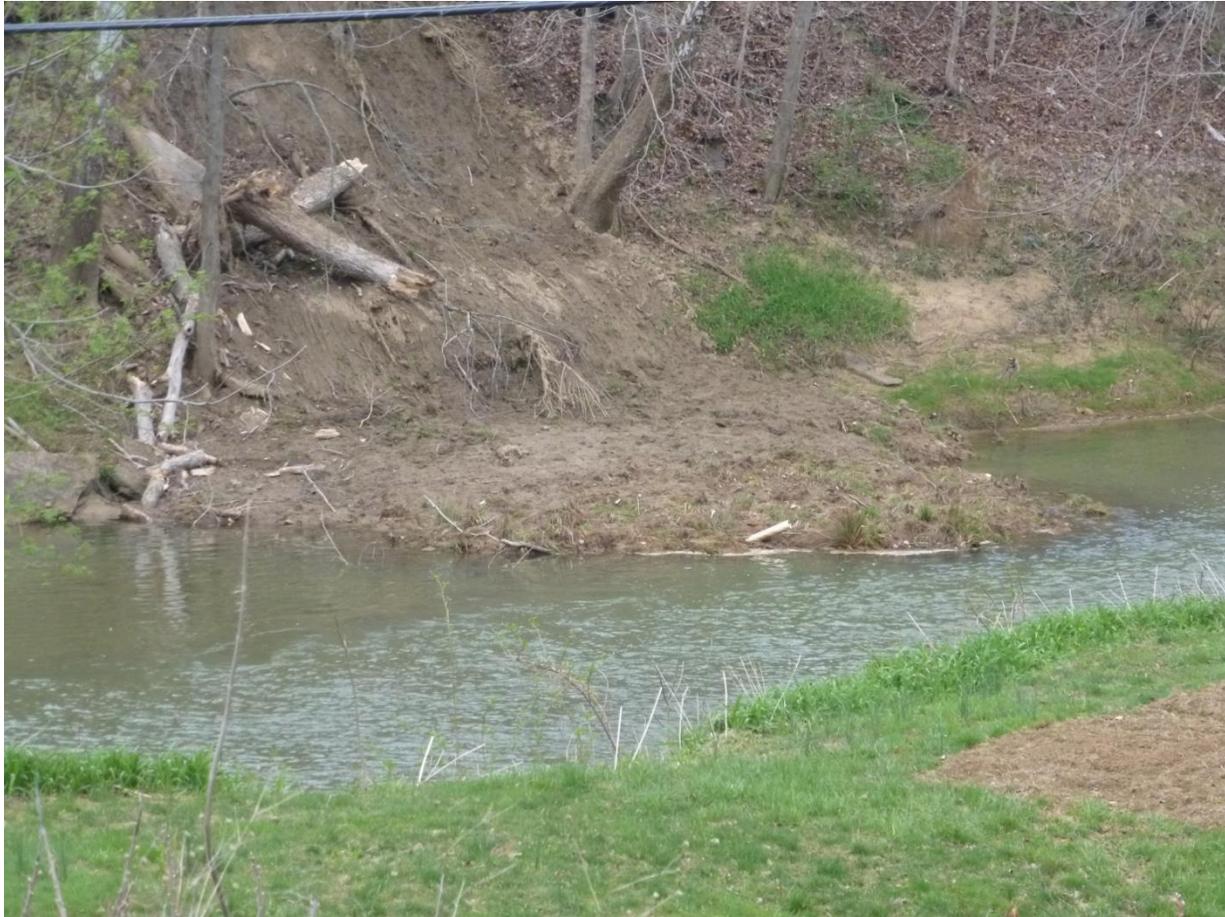
Another view of material in creek. Obvious how the material slid down the steep embankment.
