**REPORT OF
INVESTIGATION**

**AGENCY: OHIO DEPARTMENT OF TRANSPORTATION
FILE ID NO.: 2012-CA00112
DATE OF REPORT: FEBRUARY 11, 2014**

SUBJECT NAME: Kokosing Materials Inc.

ALLEGATIONS: False Billing

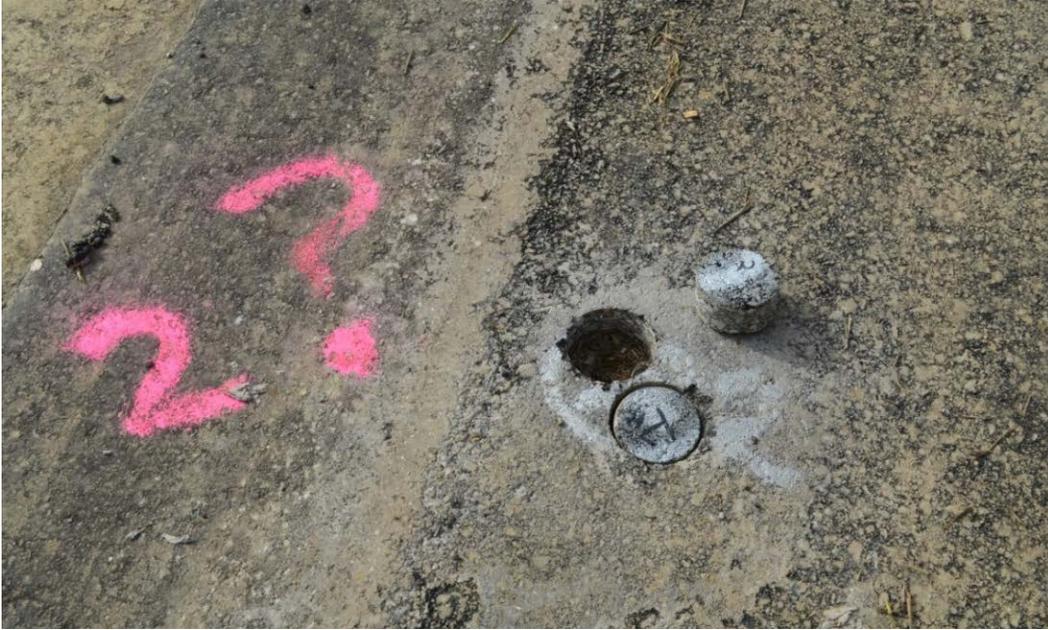
Core 1 is shown fitting into the extraction site for core 2 based on the paint markings.

Inspection of the construction site and the cores extracted by McKenzie noted several variances. The core marked “1” was actually extracted from the core 2 location as evidenced by the paint

- 1) Determine if the contract with Kokosing Construction Company allows for any remedies regarding the submission of the suspect core samples to ODOT for testing.
- 2) Revise their procedures to ensure that ODOT inspectors and/or engineers not only physically observe the extraction of the cores but that they physically observe the placement of the cores into the core box.

- 3) Ensure the core box is secured with evidence tape or another tamper-resistant method after the cores have been placed in the box.
- 4) Consider revising the policies and procedures regarding the taking of additional core samples, not considered “sister” cores, by the construction company, including the possibility of prohibiting such action or specifying the locations where such extractions can occur.

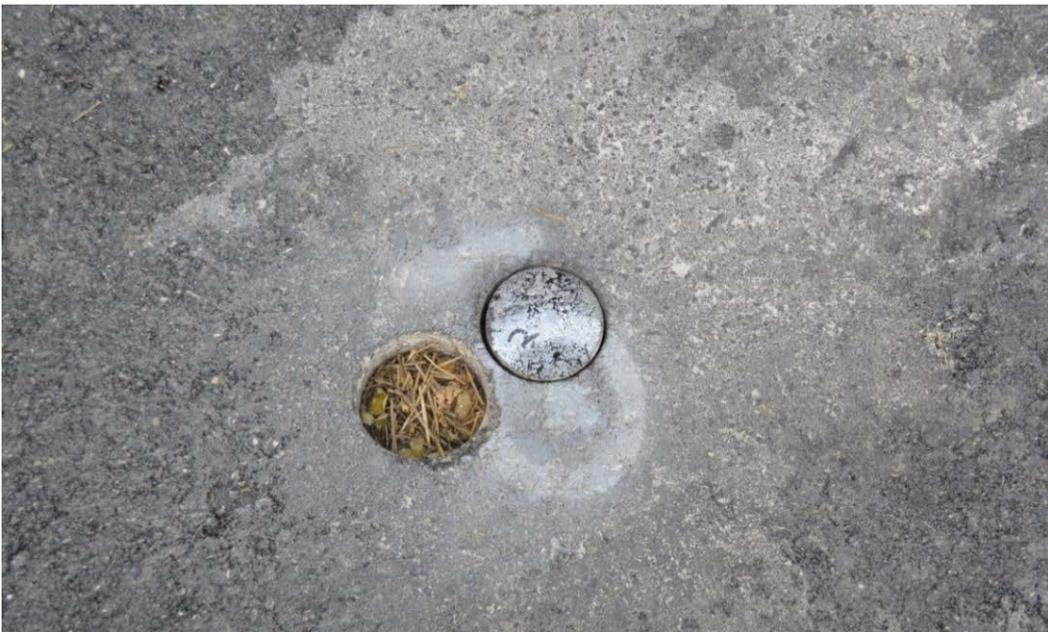
Core 2 is shown fitting into the extraction site for core 1 based on the paint markings.

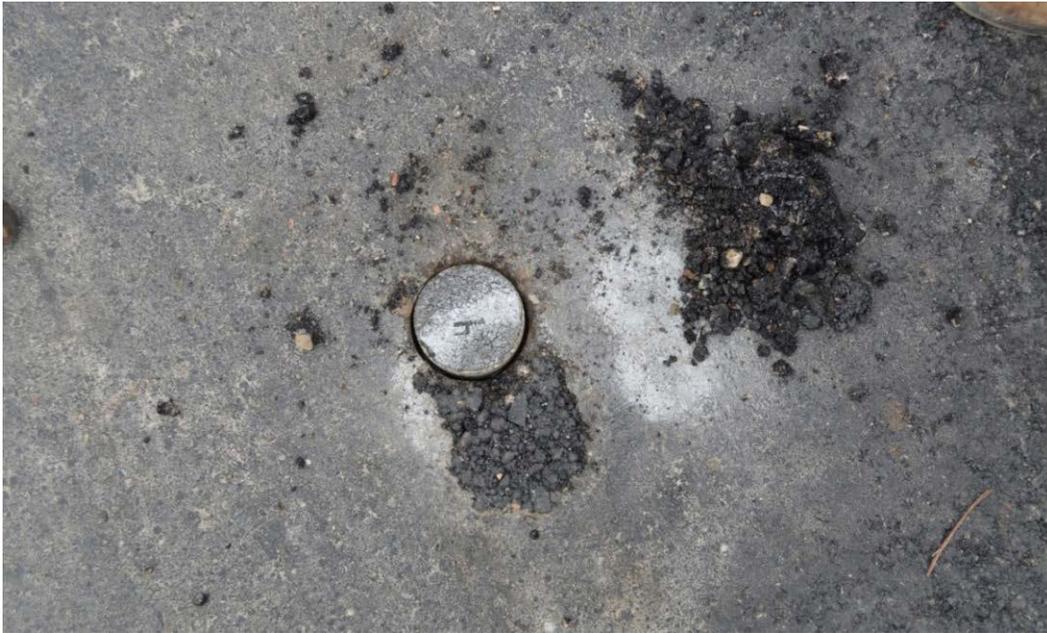
Core 4

This picture shows core 4 allegedly extracted by McKenzie in Lot 9 fits into the location of core 8 in Lot 8. Paint markings also appear to correspond.

markings, and vice versa. Other cores marked has having been extracted from Lot 9 were either taken from Lot 8 or at another location within Lot 9.

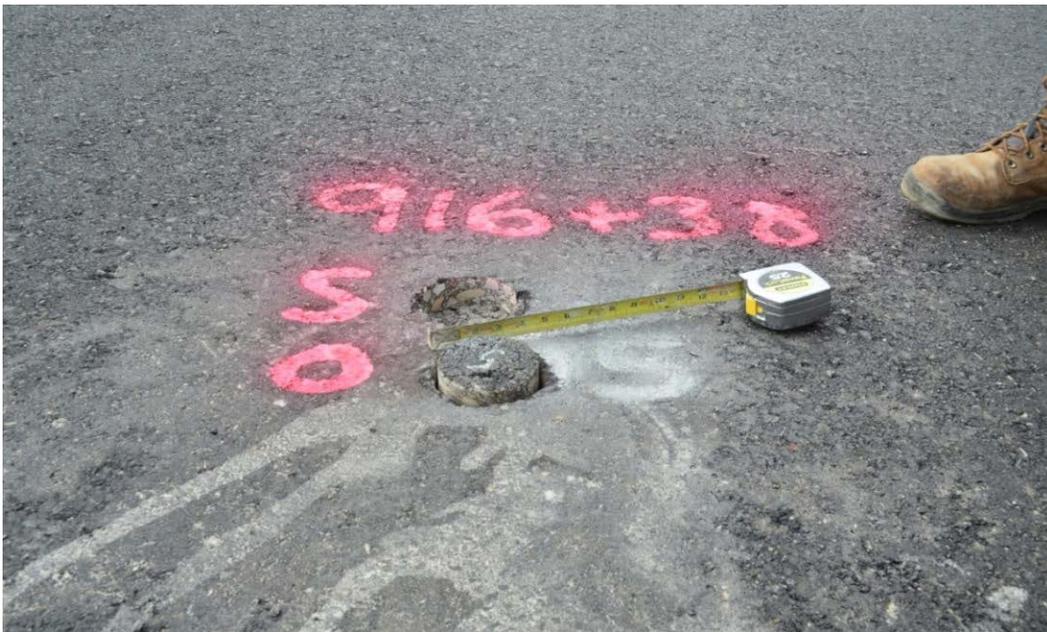
Core 5

This picture shows core 5 does not match the Lot 9, core 5 extraction site.

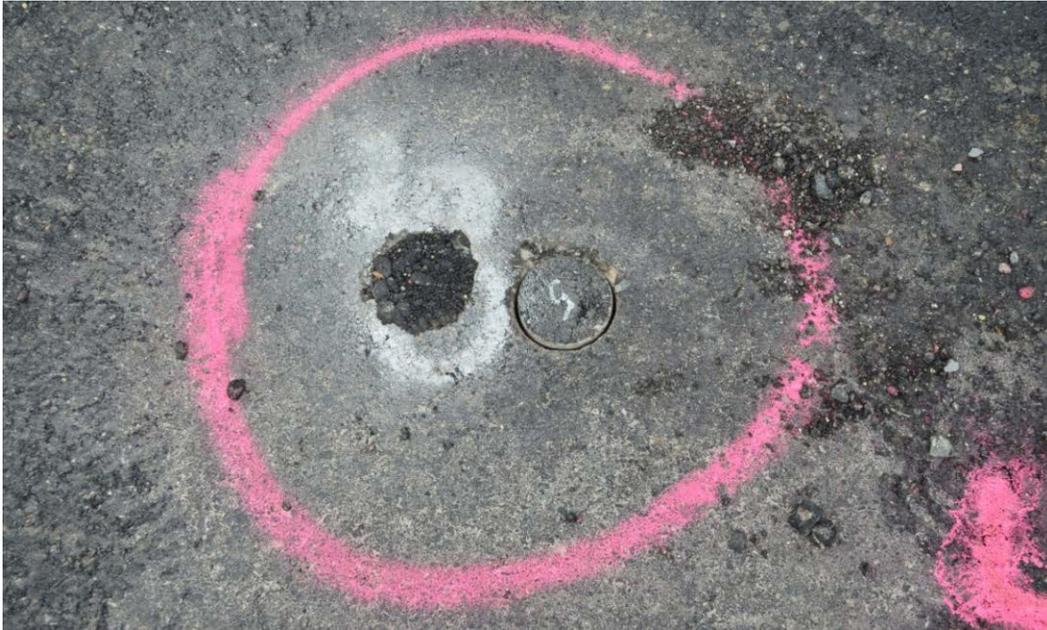
Core 5

This picture shows the same core 5, but this time the sample is shown fitting into Lot 8, core 5's location.

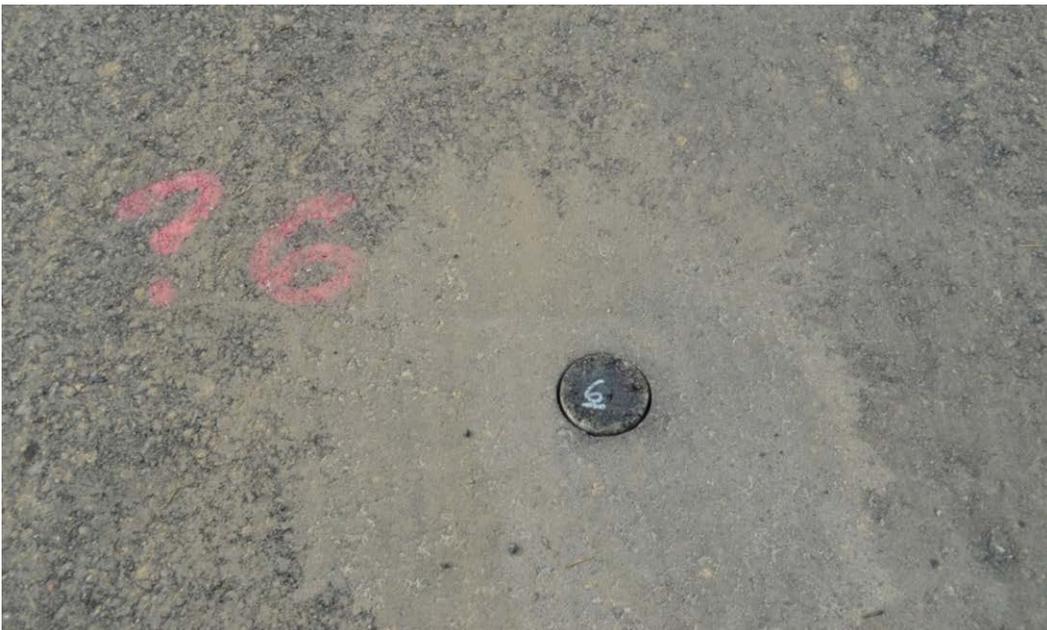
Core 6

This picture shows core 6 fitting into an extraction area in Lot 9 but near where the extraction site for core 1 is located.
